Practical experiences with the strengthening prestressed bridges using prestressed CFRP strips

Peter Koteš¹, Martin Vavruš¹, Michal Zahuranec¹, Jozef Prokop¹, František Bahleda¹, Ondrej Krídla^{1,2}

¹Faculty of Civil Engineering, University of Zilina, Univerzitna 8215/1, Zilina 010 26, Slovakia ²Research and Development institute, Slovak Railways, Hviezdoslavova 31, Zilina 010 02, Slovakia

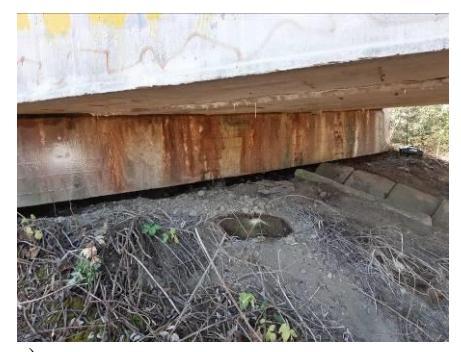
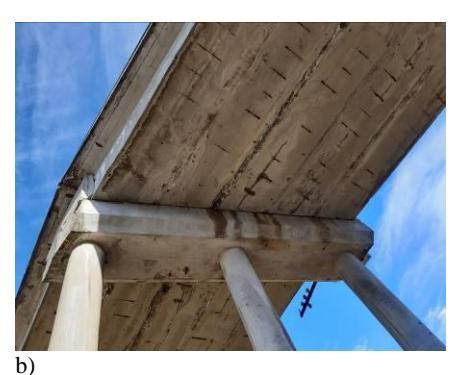
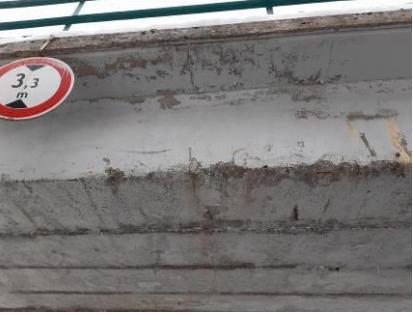
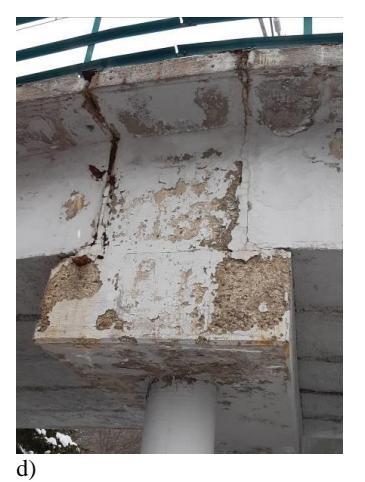
- Superstructure (Fig. 3 a d):
- water leakage between beams,
- the surface treatment that has been done recently has locally fallen off,
- locally fallen off concrete cover layer at the stirrups,
- Peter Koteš1, Martin Vavruš1, Michal Zahuranec1, Jozef Prokop1, František Bahleda1, Ondrej Krídla1,2

- the load-bearing structure is only slightly twisted at the edges of the bridge structure at the places of damage to the ledge,

- cracks were visible in the places of the cable ducts from the lower side of the beams, from where the water also flowed locally (wet places),

- concrete leaches from some cracks (local formation of drops and incrustation),

- the reinforcement (stirrups) shows a slight corrosion, the prestressing steel was detected in three places, but no corrosion of the prestressing reinforcement was detected and there was found that the cable ducts were injected,

- the cement mortar between the beams was damaged, the joints were leaking, the joints fall out in places,

- the girders in span no. 4 were (bridge n. 4) slightly damaged (edges) from road vehicles due to the low ground clearance,

- the joint between girders and cornices - longitudinal cracks were detected between the edge girders and cornices in the longitudinal direction in each field, some of which were leaking water and leaching.

- Fig. 3 The deterioration of the bridges leakage between beams and leakage through the expansion joints on the abutment cap (a), leakage through the expansion joints on the pier cap and corrosion of the beams' stirrups (b), the girders in span no. 4 of bridge n. 4 were slightly damaged (edges) from road vehicles (c), and detail of pillar bridge cup with cracks and with spalled of surface treatment and concrete cover layer (d).
 - Substructure abutments (Fig. 3 a):
 - the abutments were in a relatively good condition,
- there is considerable leakage through the expansion joints, and the cover layer was damaged locally,
 - there were nets of vertical and horizontal surface cracks on the abutments,

• Substructure - pillars (Fig. 3 b,d):

- the bridge cups of the pillars were leaked,

- the joints in supporting of girders were slightly crumbled,

- locally, the concrete cover and surface treatment fell off, corrosion of the reinforcement was detected in those places,

- a significant number of horizontal and vertical cracks in the bridge cups were found (mainly horizontal),

The design required the use of two Sika CarboDur Type S626 strips per beam with a force of 140 to 170 kN depending on the beam type (length). The cross-section of the strips is 60x2.6 mm with a characteristic strength of 2800 MPa, modulus of elasticity 165 GPa and limit strains 1.70%. The strips could not be used for the maximum possible force (approx. 240 kN) due to the anchoring, so the prestressing level is approximately 58 to 70%. The prestressing force was applied with a hand-held hydraulic press. Due to the relatively small thickness of the box-girder bottom slab (100-120 mm), it was not possible to use certified anchoring for maximum use, but anchoring using steel bond anchors from Hilty had to be designed. Compressive stresses were inserted to the cross section using prestressed CFRP strips, which eliminated tensile stresses.

In the case of pillars, the strengthening was designed so that the space between the columns and bridge caps was filled with a solid wall (bridges n. 1-3), or a wall with an opening (bridge n. 4) for better light transmission of the space under bridge. The photos after the reconstruction are shown in Fig. 5.

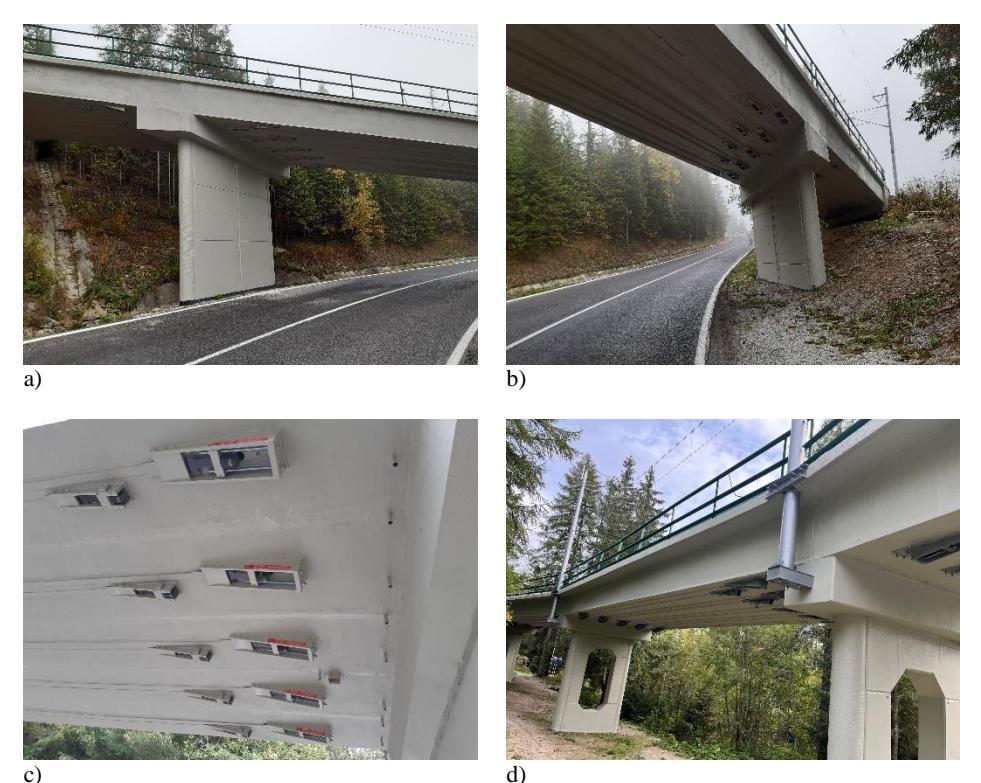
Fig. 5 The bridges after strengthening – side view of bridge n. 2 after reconstruction (a), bottom view of the structure and CFRP strips and anchorage (b), detail of CFRP strips anchoring - bridge n. 2 (c), and view of the strengthened bridge n. 4 (d).
