The condition of the prestressing tendons within the oldest post-tensioned concrete bridges in Slovakia

Jakub Gašpárek, Peter Paulík

Department of concrete structures and bridges, faculty of civil engineering Slovak University of Technology Radlinského 11, Bratislava 81005, Slovakia

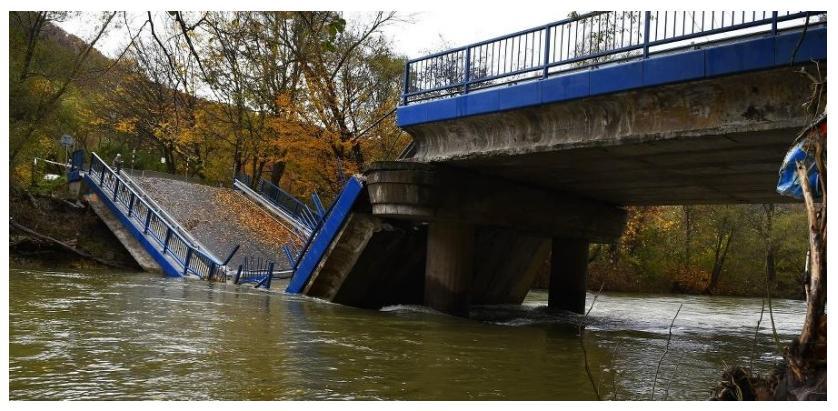
The road bridge superstructure consisted of precast PT girders (I-type shown in Fig. 2), consisting of three segments with the total length of the superstructure approximately 50 m. The girders were simply supported and formed two spans with a length of approximately 25 m. The bridge was partially reconstructed due to extensive leakage, but the reconstruction did not consider the condition of the prestressing tendons, which were not inspected during the diagnostics. In August 2020, after a major bridge inspection, it was discovered that the joints between the precast segments had opened. The bridge was immediately classified as STC level VII and closed. In October of the same year, one of the two spans of the bridge suddenly collapsed under its own weight (Fig. 5). The reason for the collapse was the gradual corrosion of defectively grouted or completely ungrouted tendons routed in corrugated metal ducts. Due to waterproofing leakage, water containing deicing salts was ingressed into the cable ducts. Chlorides accelerated the corrosion of individual wires and caused localised pitting corrosion, which led to the breakage of some ungrouted tendons and progressively led to the collapse of a span of the bridge.

Fig. 5 PT segmental bridge in Kysak - collapse of one of the two bridge spans.

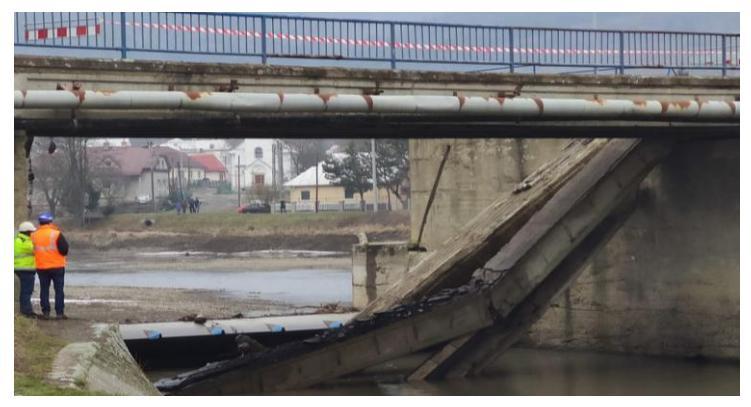
The superstructure of the road bridge consisted of precast PT Vloššák girders (Fig. 3) with a total length of superstructure of approximately 65 m. The girders were simply supported and formed three spans. These girders have very thin walls and the cover of the cable ducts is only about 30mm. The bridge was inspected in April 2019 and classified as STC level IV. In October of the same year, a sudden collapse of the outermost precast girders occurred from their own weight (Fig. 6). The cause of the collapse was corrosion of the ungrouted tendons of the outermost precast girders, where stains caused by extensive leakage of waterproofing were reported. The interaction of the individual girders in the transverse direction was meant to be ensured by transverse prestressing. However, transverse prestressing was not implemented on the construction site due to manufacturing inaccuracies (misalignment of transverse cable ducts in adjacent girders), resulting in limited load redistribution to adjacent girders after the tendons of the outermost girders corroded.

Fig. 6 Side view of the bridge

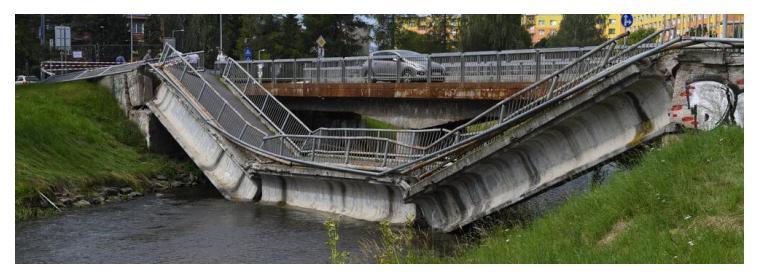
The pedestrian bridge consisted of a pair of precast PT segmental I-girders (Fig. 2), each consisting of three segments. The girders were simply supported with a length of 30 meters. In July 2020, the bridge suddenly collapsed during service without considerable overload (no fatalities, one injury). The cause was corrosion of ungrouted tendons. The last bridge inspection, which was done more than 4 years before the collapse, found no severe visible defects. After the collapse, longitudinal cracks along the tendons were discovered, indicating possible corrosion of the prestressing wires. Wider cracks probably formed only in the last phase of tendon corrosion because, in the case of ungrouted cable ducts, corrosive products have sufficient space to expand until they fill the duct and begin to exert pressure on the concrete.

Fig. 7 View of the collapsed pedestrian footbridge in Spišská Nová Ves – marking the cracks along a polygonal tendon.

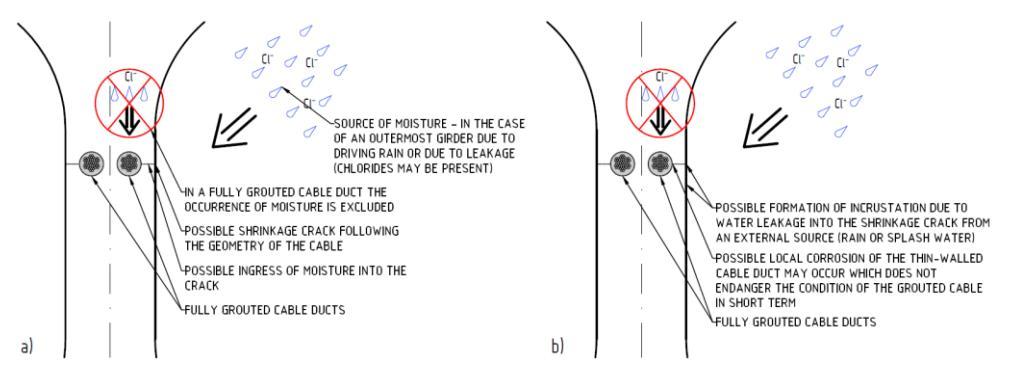
In almost all bridges, thin shrinkage cracks were observed above the cable ducts in the walls and in the precast girders' slabs and bottom webs. The condition of the tendons at the location of the cracks was verified by drilling into the cable duct, and in most cases the cable ducts were grouted or partially grouted. No significant corrosion of the prestressing cable wires was observed in the absence of moisture penetration from an external source into the interior of the cable duct according to scheme on the Fig. 8. In some cases, corrosion of the corrugated metal duct or local incrustations was observed due to penetration of water into the shrinkage cracks.

Fig. 8 Cross section through the wall of the girder - shrinkage cracks that copy the geometry of polygonal cable ducts.

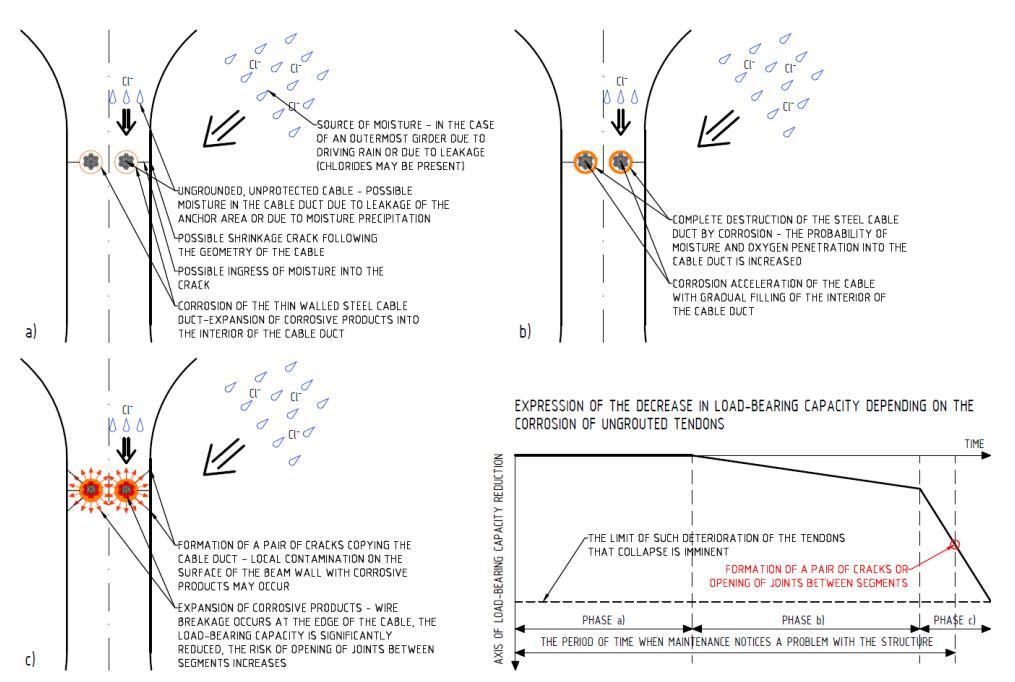
On the bridges, where a pair of cracks were observed along the cable ducts, extensive corrosion damage and breakage occurred in most cases, particularly the tendon's outermost (perimeter) wires. The crack formation is described in Fig. 9 and is very similar to the corrosion of a single rebar embedded in concrete [16]. The main difference lies in the fact that the resulting ungrouted cavity is gradually filled with corrosion products in the first stages of corrosion, which causes late crack formation [4]. The entire corrosion process has three phases. Phase a), according to Fig. 9, is characterised by the initiation of corrosion of the thin-walled corrugated metal duct and the outermost wires of the cable due to moisture in the cable duct (most often due to anchor leakage). At this stage, the corrugated metal duct still acts to some extent as a diffusion barrier that prevents the penetration of moisture and oxygen, which is expressed by the graph in Fig. 9. Once the corrugated metal duct is completely corroded (phase b), acceleration of the corrosion of the prestressing wires occurs, according to Fig. 9. Crack

development is delayed, occurring only at a late phase c), and at this stage could be noticed by bridge inspectors. However, the precast girder already suffers from a reduced load-bearing capacity.

Fig. 9 Cross section through the wall of the girder – late formation of a pair of cracks due to the expansion of the corrosive products in the ungrouted tendon and a schematic graph showing the reduction of the load bearing capacity of the precast girder due to corrosion of the prestressing tendons.

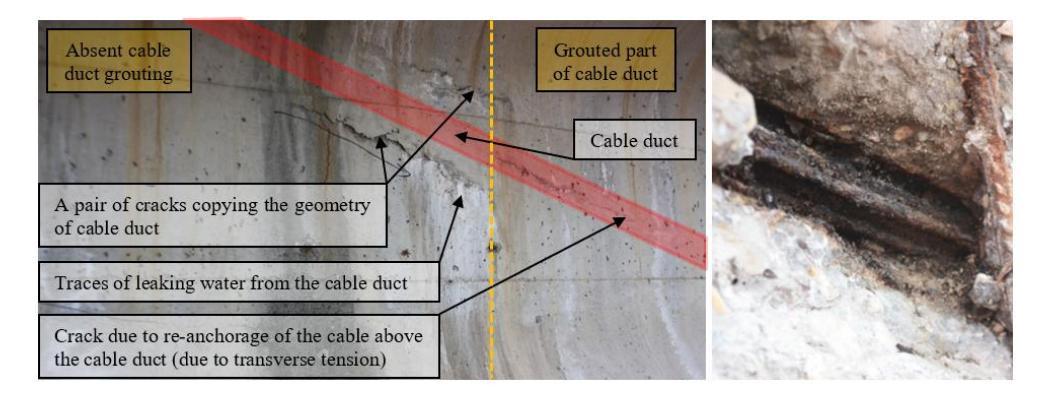
Erro! Fonte de referência não encontrada. shows the case of a partially grouted cable duct and the visible signs observed on several bridges when tendons were damaged. In some cases, the outermost wires of the tendon were torn. Since the cable duct is partially grouted, the torn wires are reanchored, and a crack is formed above the cable duct due to the transverse tension, as seen in **Erro! Fonte de referência não encontrada.**

Fig. 10 A pair of longitudinal cracks parallel to the geometry of the polygonal cable duct; on the right, an access window for inspection of the cable duct shows extensive corrosion damage (the duct is full of corrosion products).

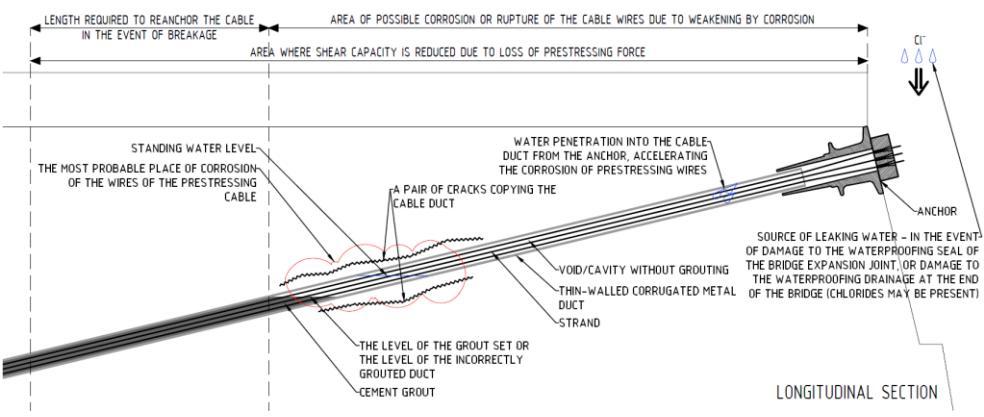
As shown in **Erro! Fonte de referência não encontrada.**, there is a decrease in the shear capacity of the girder along the section between the anchorage and the point where the cable wires are reanchored. This condition directly endangers the shear capacity of precast concrete structures in which prestressing has an important contribution to the shear resistance. In this case, if the wires break in the inclined section of the tendon, brittle shear failure may occur [10]. Since most partially grouted tendons are located in locations subjected to high shear stresses (incline positions), the permitted load had to be restricted on several bridges in Slovakia.

Fig. 11 Longitudinal section through a partially grouted polygonal cable duct.
