Study on Collapse Evaluation Method for RC Buildings Considering Redundant Failure Behaviour

Satoshi Komatsu¹, Mari Funayama², Zazirej Stanislav¹, Akira Hosoda¹ and Kuniyoshi Sugimoto¹

1. Institute of Urban Innovation, Yokohama National University, 79-5 Tokiwadai, Hodogaya, Yokohama (240-8501), JAPAN

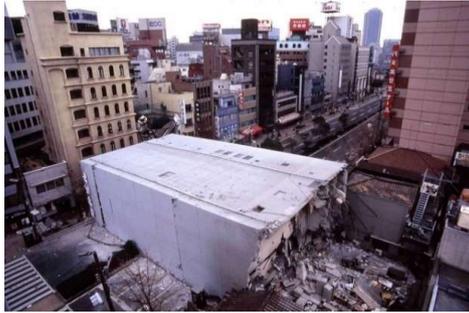
Fig. 1 Building that collapsed sideways and blocked the road [2]

We will examine two typical examples of reinforced concrete structure collapse due to earthquakes. The first is collapse of the first floor of a building with a piloti structure. In some cases, buildings used as shops, offices, garages, or warehouses do not have load-bearing walls on the first floor to maximize interior space. In such cases, the rigidity and load-bearing capacity of the first floor is lower compared to the upper floors, causing large plastic deformation to concentrate on the first floor, and ultimately leading to collapse of that floor. This vulnerability is particularly evident in buildings constructed before 1971, where many columns lacked effective shear reinforcement, resulting in numerous first floor failures. Although rare, some buildings have also collapsed sideways due an unfavourable structural centre of gravity, as shown in Figure 1.

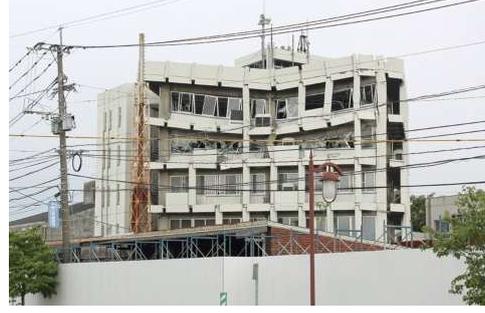
Fig. 2 City Hall Main Building with intermediate-story collapse [3]

The second typical example of reinforced concrete structure collapse is the failure of intermediate floors. There have been reports of intermediate floor collapse in buildings where the structural type was switched from steel-framed reinforced concrete to reinforced concrete, in buildings where seismic

reinforcement work was completed on lower floors, causing weakness in the floor directly above, in buildings where the number of bearing walls was reduced, in building floors where the cross-section of the columns was significantly reduced, in building floors where vertical setbacks were introduced, and in building floors where torsional vibration was induced due to the uneven distribution of bearing walls. Figure 2 shows a typical case of intermediate-floor collapse that occurred in the 2016 Kumamoto earthquake. Note that this type of collapse has not been observed in buildings constructed after 1981, following revision of design methodologies.

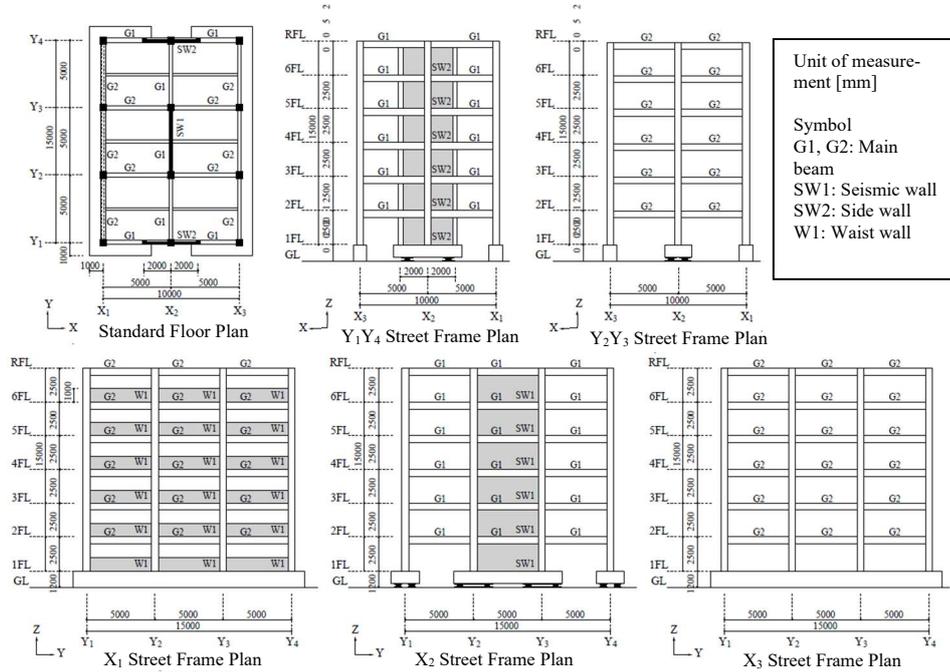
Fig. 3 Floor plan and frame diagram of the test building

Figure 3 presents the plan and frame diagram of the test building. It is a 6-story reinforced concrete seismic wall frame structure with 3 spans in the longitudinal direction (Y direction) and 2 spans in the direction perpendicular to that (X direction). The span length in both the X and Y directions is 5000 mm, and each floor has a height of 500 mm, for a total building height of 16200 mm. The cross-sectional sizes of the members are the same on each floor: main columns 500×500 mm, intermediate columns 300×300 mm, main beams (G1, G2) 300×500 mm, and secondary beams 200×400 mm. The reinforcement details of each component are as follows: the main reinforcement of the columns on each floor is 8-D19, with 2-D10 at 100 mm spacing; the seismic walls (SW1) are 150 mm thick, reinforced with double D10@300 mm spacing both vertically and horizontally, with the exception of some parts; the upper reinforcement of the main beams (G1, G2) is 3-D19, the lower reinforcement is 2-D19, and the stirrups are 2-D10 at 200 mm spacing. The design standard strength of the concrete was set at 18 N/mm^2 . However, according to reference [4], the compressive strength of the concrete test pieces cured in water at the construction site on the day of the shaking table test was 31.7, 30.7, 28.2, 27.3, 25.2, and 22.8 MPa for the first to sixth floors, respectively. The yield strength of the rebar was 398 MPa for D19 and 369 MPa for D10. The weight of each floor is approximately 1.25 MN, and the total weight of the upper part of the first floor columns was 7.50 MN.

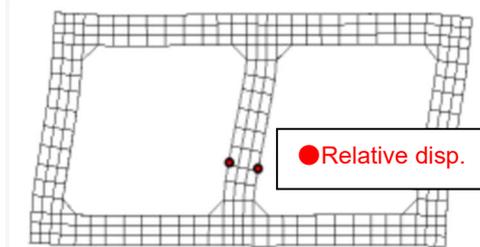
Fig. 4 Image of thickness increment of RC member

The thickness increment of RC member index, which indicates the amount of expansion in the thickness direction of the member, as shown in Eq. (1), is mainly composed of diagonal cracks (X-shaped cracks) and bond splitting cracks, and roughly corresponds to the total of those openings. This index can be applied to both one-way and repetitive loadings.

where ΔD_{lim} is the limit value of thickness increment of the RC member [mm], p_w is the shear reinforcement ratio, and D is the member thickness [mm]. Figure 4 shows an image of the nodes used in the calculation. The thickness increment of RC member index is effective for evaluating out-of-plane shear failure because it does not detect the opening of bending cracks but detects the opening of diagonal shear cracks. In this study, relative displacement was calculated between element nodes at the same elevation, and the maximum value was adopted for evaluation. The first term (5 mm) focuses on members without out-of-plane shear reinforcing bars. According to previous experiments with member thicknesses of 400 mm to 800 mm and axial force ratio of -0.05 to 0.05 , the residual load carrying capacity rate in the direction perpendicular to the member axis is 60% to 95% when there is expansion of 5 mm in the thickness direction. The second term ($2.5p_w D$) accounts for the distribution of cracks in members due to the use of shear reinforcing bars. Analytical case studies further confirmed that the relationship shown in Eq. (2) was found across members with different specimen lengths, rebar ratios, and rebar diameters.

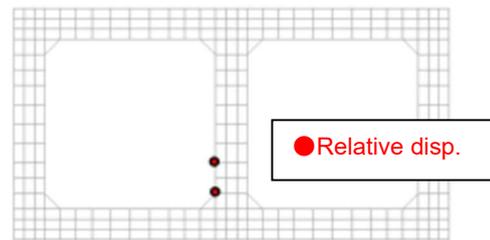
Fig. 5 Image of relative displacement on compressive edge in RC member

It is well known that concrete damage under uniaxial compressive stress conditions occurs locally. Experimental studies have shown that the failure zone remains within 200 mm in both cylindrical and rectangular specimens with varying height-to-width (H/D) ratios [10]. The compressive failure of concrete is often evaluated using principal compressive strain. However, since strain is greatly affected by the element size dependence in the analysis model, the limit value is set from the in-element reference length determined from the direction of the principal strain [7]. Based on the above physical phenomena and the current strain-based design concept, we verified that setting a deformation limit of 1% over a 200 mm node interval results in a more conservative (safer) design than the current design method. In other words, the relative displacement between the nodes 200 mm away from the member edge at the compressive edge of the RC member is 2 mm (200 mm multiplied by 1%), which is used as the index and limit value proposed in this study. The node positions used for the calculation are shown in Fig. 5.

where $\Delta l_{lim}'$ is the limit value of relative displacement on the compressive edge [mm]. However, the nodes used for the verification must be at least 200 mm away from the end of the member excluding the haunch. In the case of the in-plane shear failure mode, the direction of the principal compressive strain in the element may deviate by up to 45 degrees relative to the direction between the nodes. However, we have checked that even if the direction deviates by 45 degrees, setting the limit value of the index to 2 mm ensures that the evaluation remains conservative, regardless of the direction of the principal compressive strain.

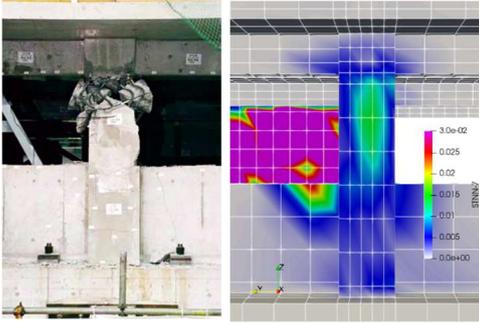
Fig. 6 Damage to the 1st floor column (X_1Y_3) and maximum principal strain

The maximum principal strain results for the first-floor columns of the test structure after the seismic wave input are shown in Figs. 6, 7, and 8, and the maximum principal strain results for the entire test structure are shown in Fig. 9. As in the experiment, the damage was concentrated on the first floor, and the analysis results closely matched those of the experiment. In the experiment, the first floor columns

X_1Y_2 and X_1Y_3 , which had waist walls, experienced shear failure. The analysis also revealed significant damage in the first floor columns X_1Y_2 and X_1Y_3 .

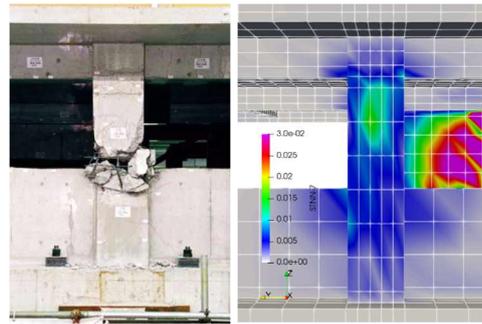
Fig. 7 Damage to the 1st floor column (X_1Y_2) and maximum principal strain

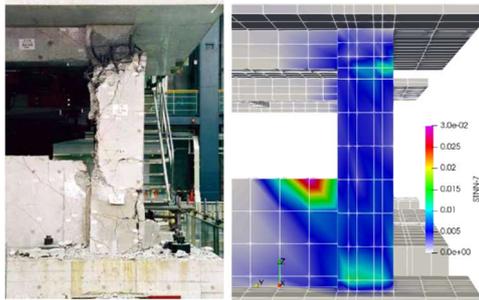
Fig. 8 Damage to the 1st floor column (X_1Y_1) and maximum principal strain

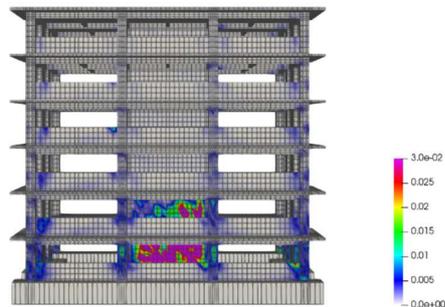
Fig. 9 Damage to the entire building (maximum principal strain)

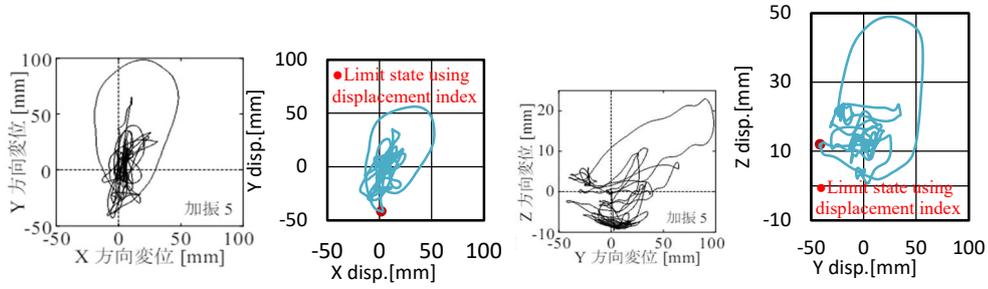
Fig. 10 Inter-layer displacement in the X-Y direction (100% amplitude)

Fig. 11 Inter-layer displacement in the Y-Z direction (100% amplitude)

The inter-layer displacement between the first and second layers of X-Y and Y-Z at X_2Y_1 at an amplitude magnification of 100% in the experiment and analysis is shown in Figs. 10 and 11, respectively. The analysis results showed displacement approximately 50 mm smaller than the experimental results in the Y direction, and approximately 30 mm greater in the Z direction. Although the displacement in the Z direction did not turn negative (the side where the building sinks) after damage, the overall results, including large displacement and damage during shear failure, were closely aligned with the experimental results. One possible reason why the Z-direction displacement did not turn negative is that the model used in the analysis did not fully capture the decrease in restraining force caused by cover peeling and the accompanying rebar buckling.

In the figures, the points where any of the columns exceeded the limit value for any of the displacement indices are marked with red circles. Of the total duration of 60.32 seconds, the “relative displacement on compressive edge in RC member” exceeded the limit value first at 50.30 seconds, when the amplitude ratio was 100%. From these figures, it can be observed that the index reached the limit value when the displacement in the Y direction swung to the most negative side. In the experiment,

the limit state was reached at an amplitude ratio of 100%, and collapse occurred at 60%. This suggests that this index can reasonably evaluate the limit state.

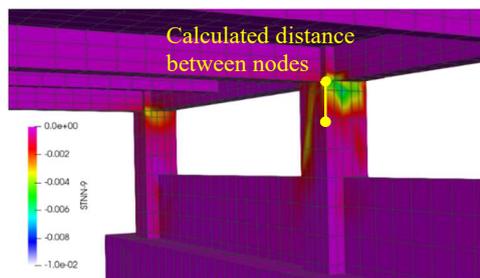
Fig. 12 Minimum principal strain of column X_1Y_2

Figure 12 shows the minimum principal strain contour of the column where the compressive edge displacement difference reached the limit value. It can be seen that shear compression failure occurred in the column on the first floor that was evaluated. This failure is likely due to the effective reduction in the shear span ratio (a/d) to approximately 1.67, caused by the presence of the waist wall. Meanwhile, the “thickness increment of RC member” also exceeded the limit value, albeit with a delay. This occurred at two first-floor columns, X_3Y_1 and X_3Y_4 . Figure 13 shows the contours of the columns where the “thickness increment of RC member” exceeded the limit value. At the bottom of the columns, large maximum principal strains occurred due to the development of bending cracks, but the index did not reach the limit value at these locations. At the top of the columns, diagonal cracks began to develop, eventually causing the index to exceed the limit value.

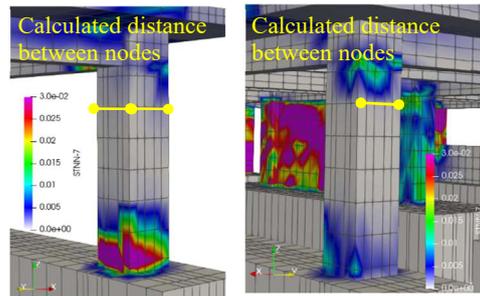
Fig. 13 Maximum principal strain (left: X_3Y_1 column, right: X_3Y_4 column)

The above indicates that the failure mode can also be appropriately estimated using these indices. After loading, the “relative displacement on compressive edge in RC member” exceeded the limit value in all columns. In particular, “relative displacement on compressive edge in RC member” was greater than 10 mm in more locations on X_1 Street than on X_3 Street, with concentrations in X_1Y_2 and X_1Y_3 . Thus,

the proposed index clearly reflects that the restraint provided by the waist wall had a significant influence on the damage to the columns.
