# Prioritizing criteria for intervention on Brazilian railway concrete bridges affected by chemical reaction

Due to systematic chemical reaction cracks identified in concrete foundation pile caps of some railway bridges in southeastern Brazil, the concessionary developed a management plan with the main objective of maintaining the bridges in service. The strategy is to intervene annually in a greater number of bridges that present damage with the challenge of seeking technically viable solutions, enabling faster and more cost-effective while mitigating risks related to structural and durability issues. A comprehensive evaluation of the progression of the processes deteriorating the concrete elements was conducted, aiming to identify indicators that can be effectively monitored. As a result of the study, additional test procedures were performed on concrete extracted from the bridges, including the Damage Rating Index (DRI), the Stiffness Damage Test (SDT) and the cracking index (CI). These procedures were developed to assess both the current condition of the concrete and its potential for further expansion or distress due to chemical reactions. Based on the test results and the da

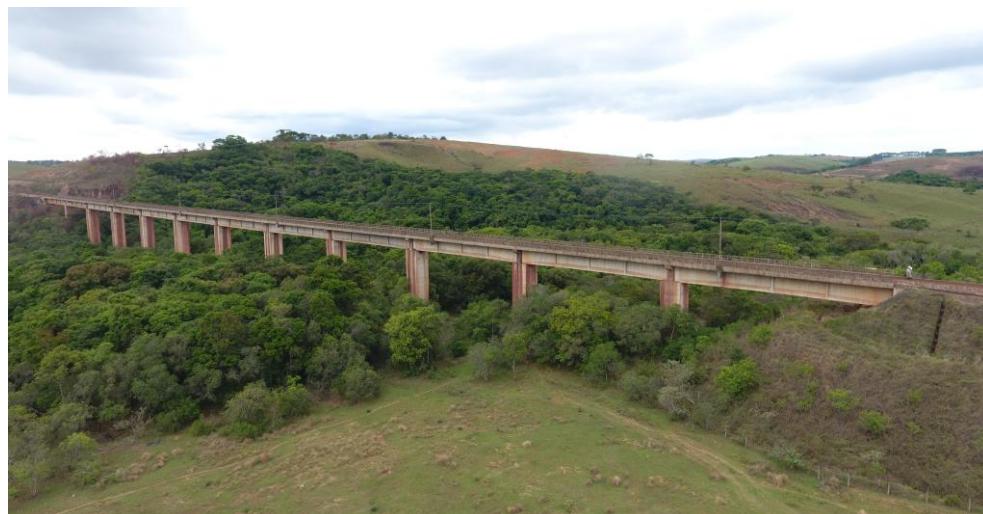
Fig. 1. A typical concrete bridge of Ferrovia do Aço (FA) Railway

The vast majority, 109 bridges of FA railway, are concrete bridges, with lengths ranging from 19m to 668m, and with spans around 25m. The average height of the bridge columns is around 30m, supported by concrete pile caps with average dimensions around 8m in plan and 3m height. The pile caps are

normally supported by concrete piles with diameters of approximately 1.2m, and a number of concrete piles that can reach 30 in the same block.

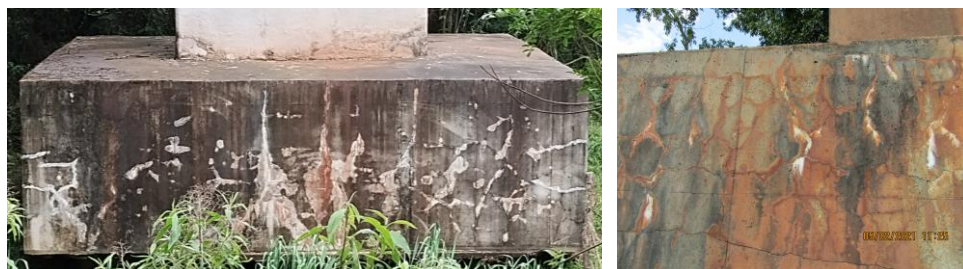
Fig. 2. Typical cracks identified on concrete pile cap of FA bridges

During inspections, typical damage caused by chemical reactions, such as mosaic-shaped cracks, has been observed in pile caps, columns and, more recently, in slabs of the FA Railway's concrete bridges. To diagnose these issues, petrographic analyses and scanning electron microscopy tests were conducted. The cracks were identified as Alkali-Aggregate Reaction (AAR) and Delayed Ettringite Formation (DEF).

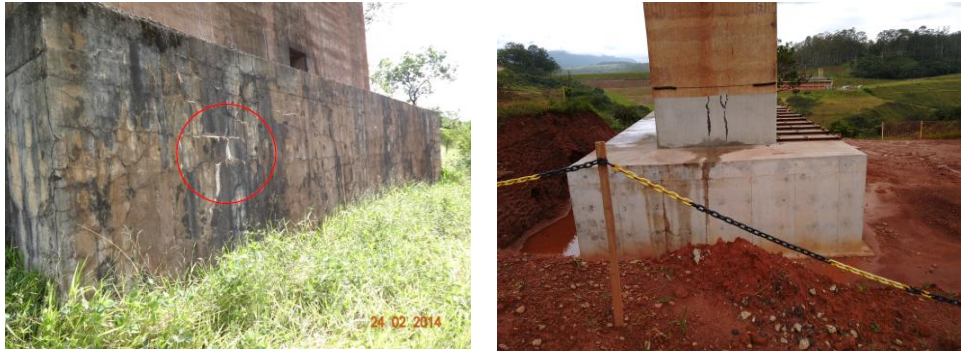
Fig. 5. Concrete pile caps of Soledade Viaduct, before and after intervention

An interesting “physical” solution to address durability-related distress caused by AAR involves reducing water ingress and repairing damaged concrete elements. This approach was implemented on the concrete pile caps of the Soledade Viaduct, located in Congonhas, in the State of Minas Gerais. This bridge is supported by 24 columns on concrete pile caps and 2 concrete abutments. The pile caps are rectangular with variable dimensions: the smallest ranging from 6.50 meters to 11.00 meters, and the largest from 14.80 meters to 12.80 meters.

By comparing the results of NDT tests and inspections conducted in 2014 and 2018, it was concluded that there was no significant progression of the chemical reaction during this period. Therefore, to prevent the water table from coming into contact with the bottom face of the pile caps, earth moving was undertaken to fully expose the vertical faces of the pile caps, as they had been mostly filled previously. Following this, a deep drain was installed around all the blocks, effectively lowering the water table in the area. To protect slopes and other surfaces from erosion after the earth moving, hydroseeding was applied and concrete gutters were installed.

Due to the deterioration observed in the concrete pile caps, additional interventions were necessary to ensure the stability and functionality of the bridge. Initially, three centimeters of the reinforcement cover was removed from the vertical and horizontal surfaces of the pile caps, as these surfaces exhibited extensive cracking. Large cracks exceeding 1 mm, which extended into the interior of the blocks, were

injected with cement grout and crystallizing additives. New reinforcements were installed, using connectors to ensure adhesion between the old and new concrete in order to prevent the residual expansive reaction process. The covering was then reconstituted by applying a layer of at least five centimeters of shotcrete, containing cement crystallization additives, to waterproof the lateral and upper surfaces. A screen was installed on the upper horizontal surface of the block to avoid shrinkage, and a slope was created to prevent water pooling.

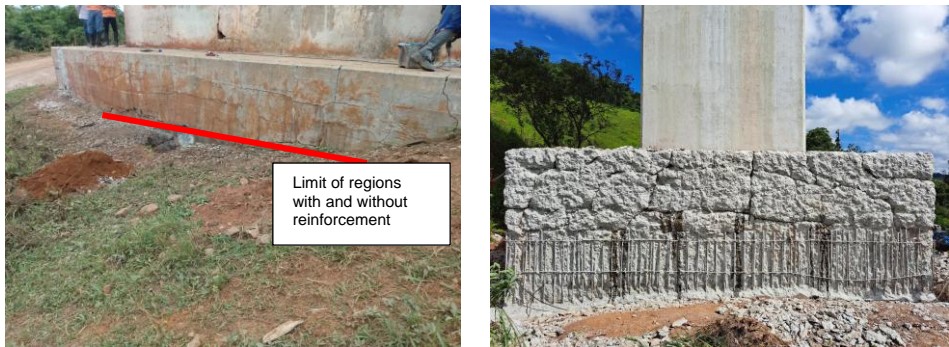
Fig. 6. Concrete pile caps of Viaduct 074-FA, during inspection and after cover removal

Another solution for durability-related distress due to AAR is the injection of cracks combined with concrete reinforcement. This method was applied to the concrete pile caps of Viaduct 074-FA, located in Coronel Xavier Chaves, in the state of Minas Gerais. This bridge is supported by 7 columns on concrete blocks and 2 concrete abutments. The pile caps are rectangular, with dimensions of 11.7meters X 6.6m X 2.5m. An interesting aspect is that the original reinforcement of the pile caps of this viaduct was installed only in its lower half. This detail was specified in the original design and later confirmed during the intervention, Fig. 6.

Due to the structural design of the pile cap, it was possible to measure the expansion of the non-reinforced region (composed solely of concrete) when compared to the reinforced concrete region. The average expansion measured across the four faces of the block was 0.24%, indicating a high level of damage, as shown in Table 1. Also, the crack index CI on the block faces was measured, resulting in a average CI of 4.6. These values were compared and found to align with the correlation between CI and expansion presented in [5]. Therefore, it was concluded that no further significant expansion is expected on the pile caps of Viaduct 074-FA. The chosen solution was the injection of the cracks to enhance the bridge's durability, along with installing reinforcement in the non-reinforced region of the pile cap.
