# Elements with shorter lifespan and their maintenance, the impact of a poor design on cost and carbon footprint

# Lara Rueda Díaz-Portales and Carlos Polimón Olabarrieta

Mott MacDonald, Paseo de la Castellana, Madrid, Spain Retineo Ingeniería, Avenida de Filipinas, Madrid, Spain

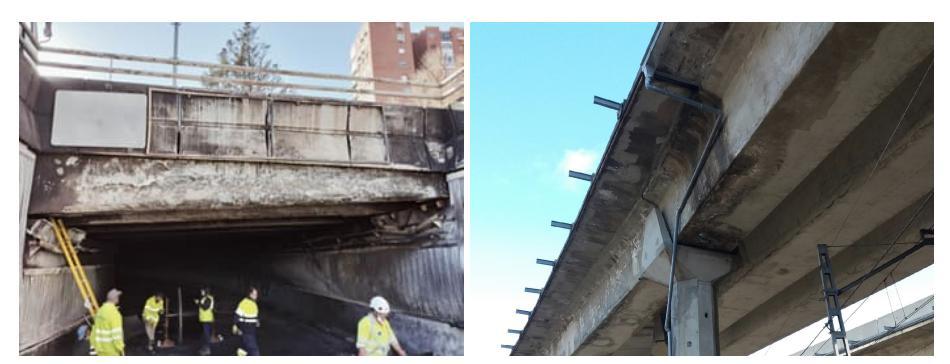
Fig. 1 (Left) Beams and bearings affected by a fire beneath the deck of a bridge. (Right) Premature deterioration due to a design of the expansion joint in zig-zag with the beams instead of skewed.

Certainly, accidents are a reason for replacements and repairs before the lifespan, from bridge strikes to fires, yet premature deterioration due to poor design of the expansion joints and failures of waterproofing leading to corrosion might be more common (Fig. 1).

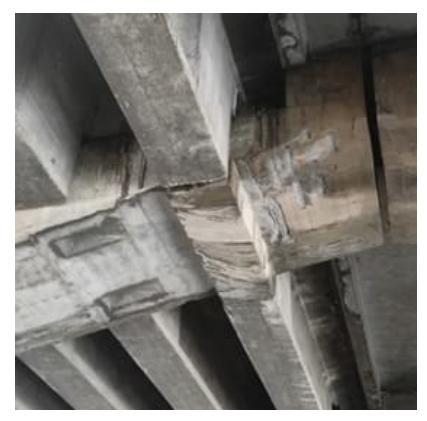
Fig. 2 Concrete spalling as a consequence of an inadequately modified drainage system.

Similarly, a bad enlargement design could significantly affect the condition of the bridge. Fig. 2 shows the deterioration after a defective modification of the drainage during an enlargement.

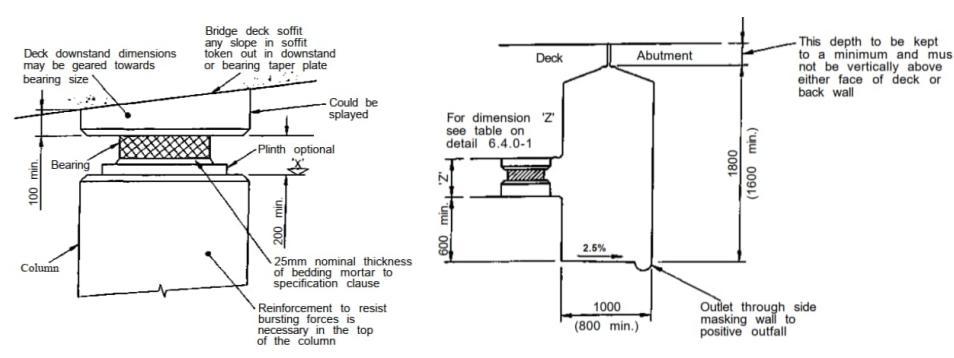
Fig. 3 (Left) Detail 6.4.0-4 from Ciria C543 [4] showing bearing plinth at discrete column guidelines. (Right) detail 6.5.0-2 from Ciria C543 showing recommended dimensions for abutment galleries.

In the United Kingdom the C543 Bridge detailing guide published by CIRIA in 2001 has been widely adopted and included in the bridge design statement of the projects [3]. The guide aimed to improve the quality and standardisation of construction details with a focus on reducing the potential for water ingress into highway bridges and their maintenance problems. It was written with the best understanding and knowledge of the time in the UK and, although it does not cover all situations and needs, it is a recommended start which could be replicated in other countries. See examples in Fig. 3.

It is worth noting that the 930mm gallery, Fig. 14 (left), is wider than the 800mm minimum given in C543, Fig. 3 (right). Guidelines such as C543 may not consider the material needed for repairs and therefore, the use of the bare minimum should be challenged when necessary.

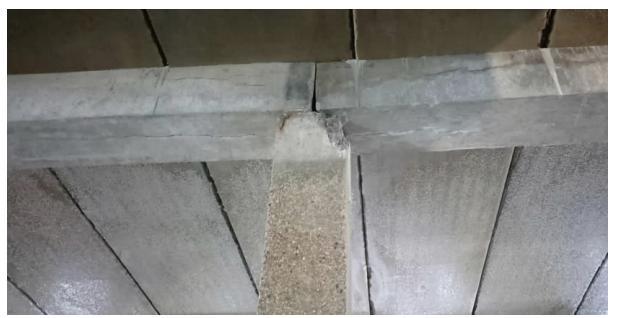
Fig. 4 Detail showing displacements, cracks and spalling at the corner.

The first case study is a tank for water already treated within a treatment plant. It is a cylindrical-shaped structure made of reinforced concrete. The tank is covered by a structure comprised of a lightened slab with a compression layer on top of concrete beams supported by columns (Fig.4). The dry connection between columns and beams resulted in most of the beams resting on the edges of the columns, causing both elements to break.

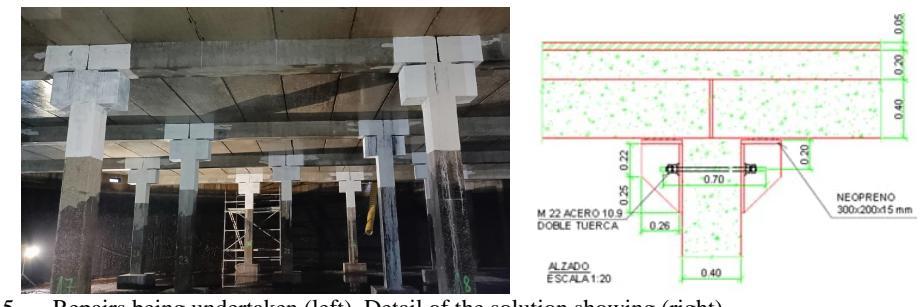
The solution adopted consisted of the installation of steel brackets to unload the column and move the support area towards the centre of the span. Since the column was thin, there was no other option but to anchor the brackets using through-holes and tension bars (Fig. 5). This intrusive and delicate work requires knowing the condition of the concrete and the location of the reinforcement.

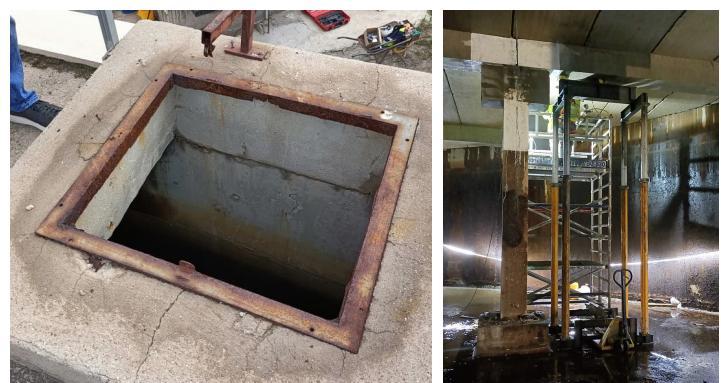
Fig. 6 (Left) Access hole; (right) the ancillary structure used during the works.

In addition, this repair was not considered during the design stage, and therefore, the structure was not prepared for the required change of supports. There was only a small access hole to introduce the necessary material and equipment inside the tank (Fig. 6). A creative system was required consisting of a bespoke small spider crane designed for the occasion (Fig. 7).

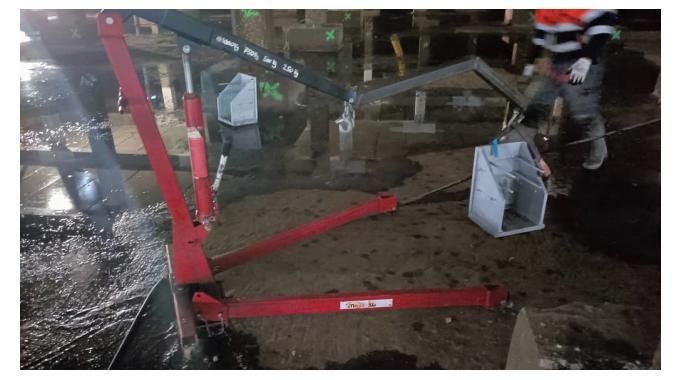
Fig. 7 Bespoke small spider crane designed for the works.

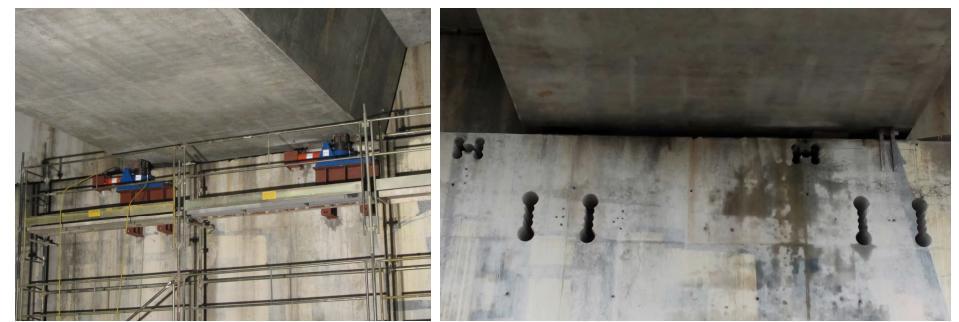
Fig. 8 (Left) Ancillary works. (Right) the trace left afterwards.

The second case study is shown in Fig. 8. The bridge was not prepared for the replacement of the bearings at the abutments. It was necessary to embed some brackets made of steel beams (HEB and IPN) at the face of the abutment to take the reaction of the supports given their great magnitude.

4 Elements with shorter lifespan and their maintenance, the impact of a poor design on cost and carbon footprint The design should have considered reinforced concrete cantilevers at the abutment or leaving enough room under the deck for the installation of jacks.

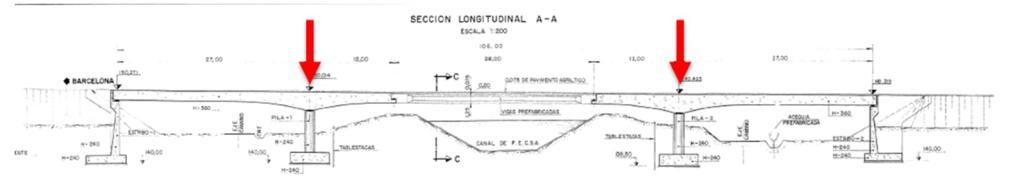
Fig. 9 Elevation of the bridge showing the resultant of the deck weight at the circular piers.

The structure in the third case study is a three-span highway bridge consisting of a reinforced concrete superstructure supported by two circular piers at each support location (Fig.9). It required a routine replacement of the bearings. Because a channel nearby did not allow excavation, it was impossible to build an ancillary tower, where to place the jacks, on top of the foundation of the piers. Furthermore, the jacks did not fit on the piers, nor could brackets be anchored to the double cylindrical columns as in the previous case, due to their small size.

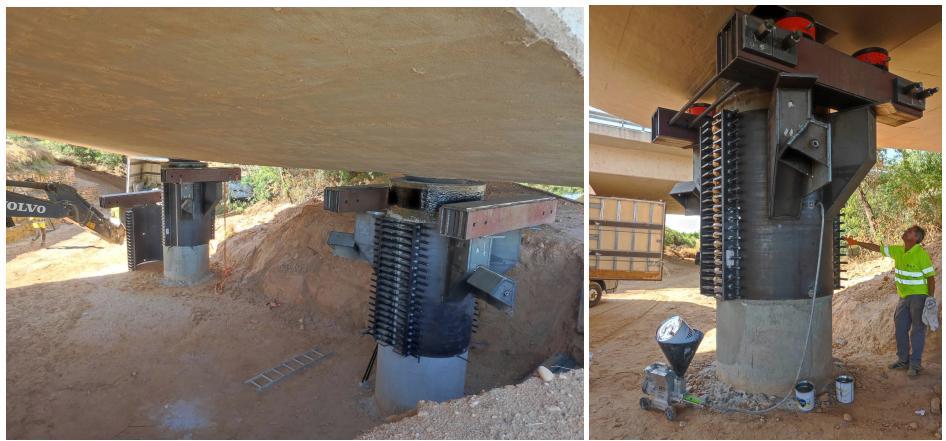
Fig. 10 (Left and right) Collars designed due to the lack of room for a routine jacking procedure.

To lift the deck, two bespoke friction jacking collars were designed with a minimum design load of 1400 tons each. Each of these collars consisted of two cantilevered beams welded to a collar with a total steel weight of 10t (Fig.10). Just the change of supports cost 200,000 euros.

The carbon footprint of this jacking collar is a huge addition to the usual embodied carbon for maintenance works. It was not calculated at the time and for this study is enough to compare the 10 tons of steel used for both collars and two elastomeric bearings. Table 1 shows the disproportional impact of the required solution. The steel alone, not including the embodied carbon due to assembly and welding, is seven times bigger.

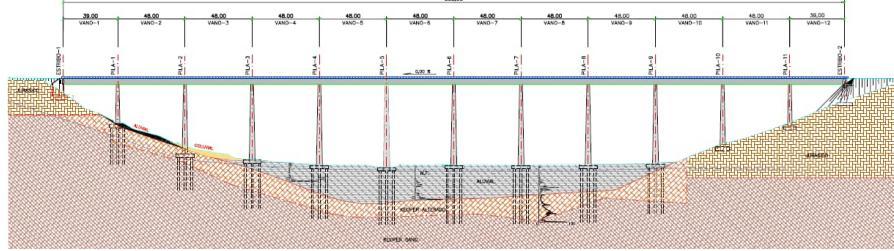
Fig. 11 Elevation of the viaduct.

The fourth and last case study is a viaduct carrying the high-speed train line between Madrid and Barcelona. It consists of twelve continuous spans with a concrete box superstructure with external prestress tendons within the box (Figs.11 and 12). An annual inspection of railway viaducts in Spain revealed a ruptured tendon, and subsequently, corrosion problems were detected in all of them.

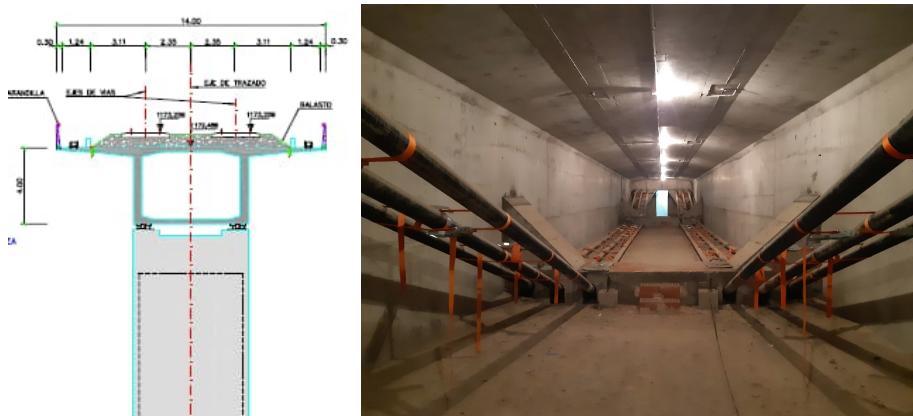
The maintenance work consisted of replacing two families of external prestressing, raising the deck diaphragm at the fixed abutment by one meter, and concreting the interior of the box to anchor the new tendon.

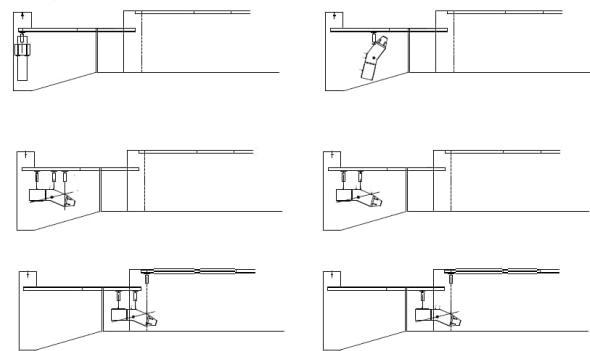
The machinery required to replace the tendons had to be transported within a 930 mm wide gallery with straight corners. A custom-made rail system with pulleys was installed to move through the confined space (Figs. 13 and 14).

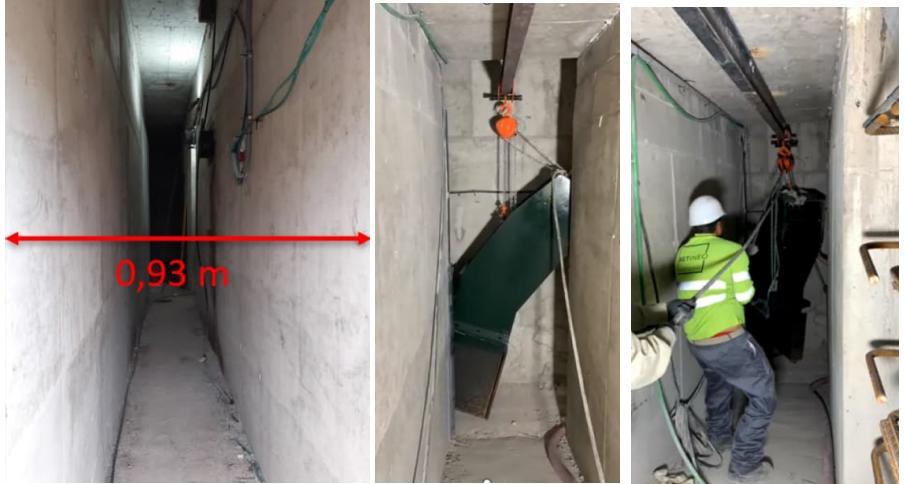
Fig. 14 (Left) Gallery. (Centre and right) tendon anchor system being moved through the gallery.

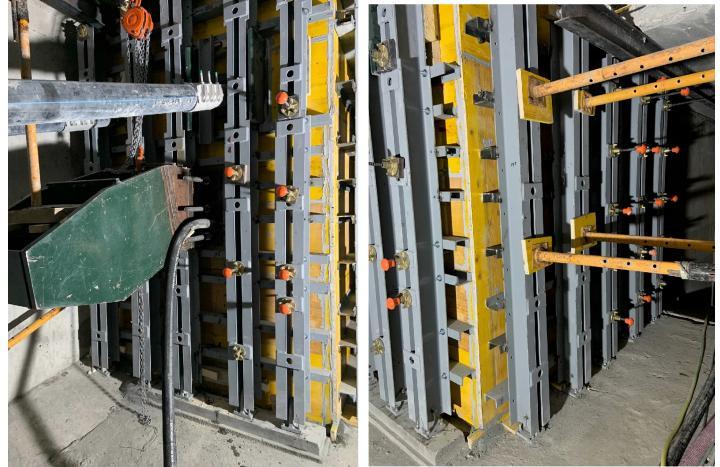
Fig. 15 Formwork of the anchor system

Another challenge during the maintenance work was the necessary formwork. This had to be custommade (Fig. 15). Currently, manufacturers and suppliers do not offer such small formwork, so the contractor had to build it with bolts, in a Mecano-style.
